# **The Road Inventory of Deer Flat National Wildlife Refuge Nampa, ID**

Prepared By:  
Federal Highway Administration  
Central Federal Lands Highway Division  
April 2013

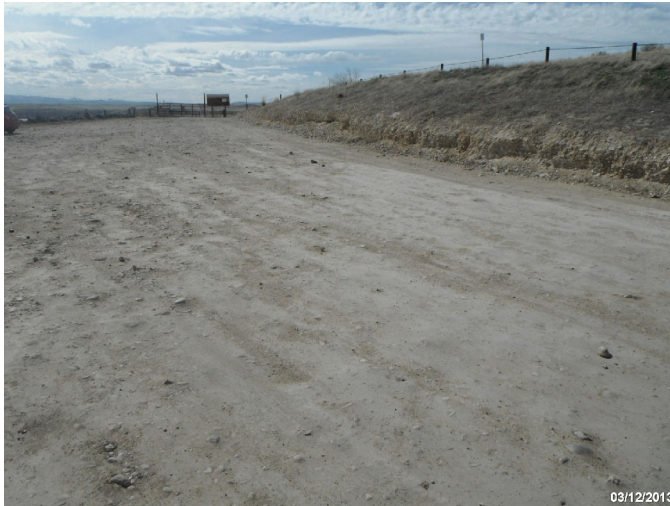
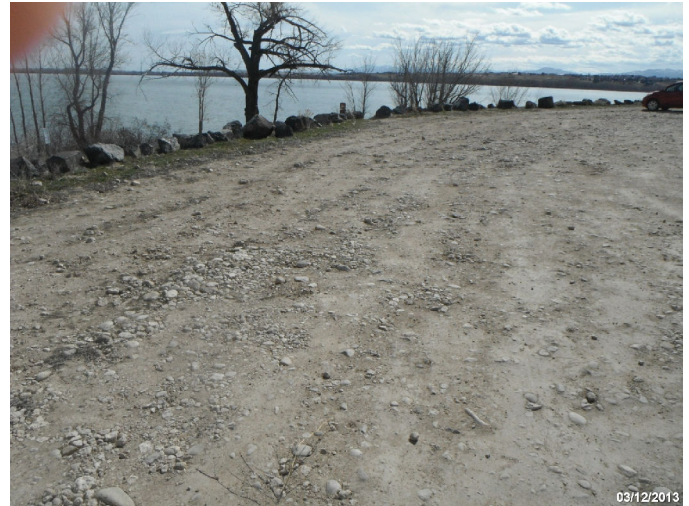
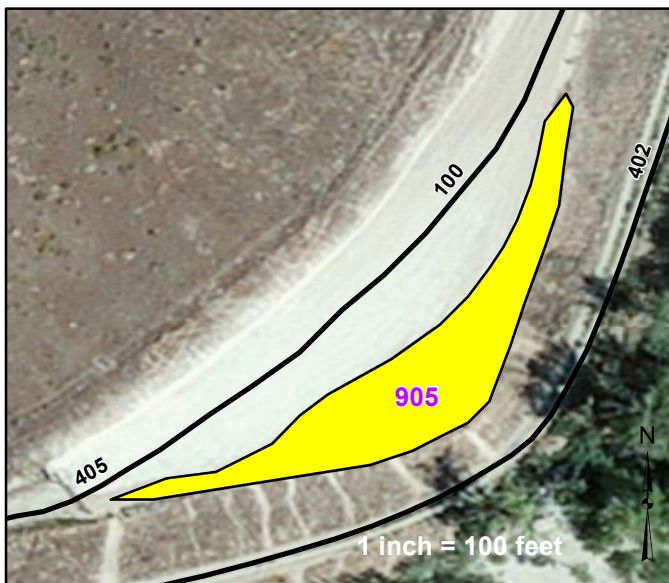
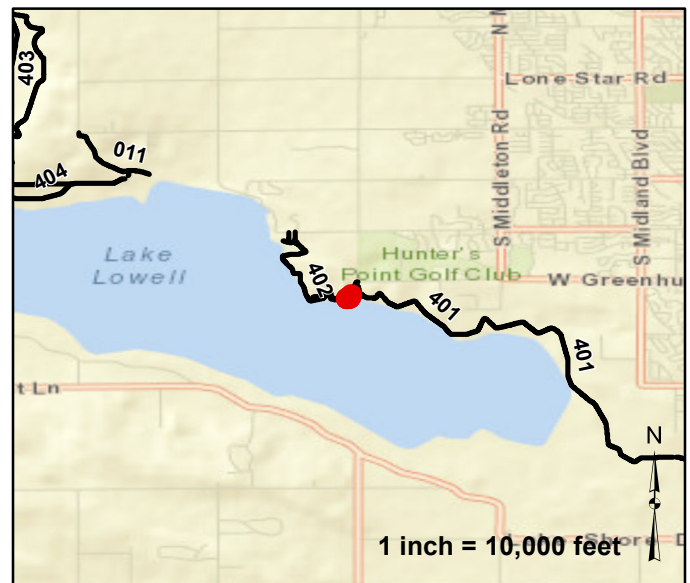
# Route Number: 905

Asset Number	Area (Sq Ft)	Spaces	Condition	Surface Type	Cost to Improve	Inspection Date	Current Replacement Value
10042378	6249	20	Fair	Gravel	\$1,700	03-12-2013	\$31,600

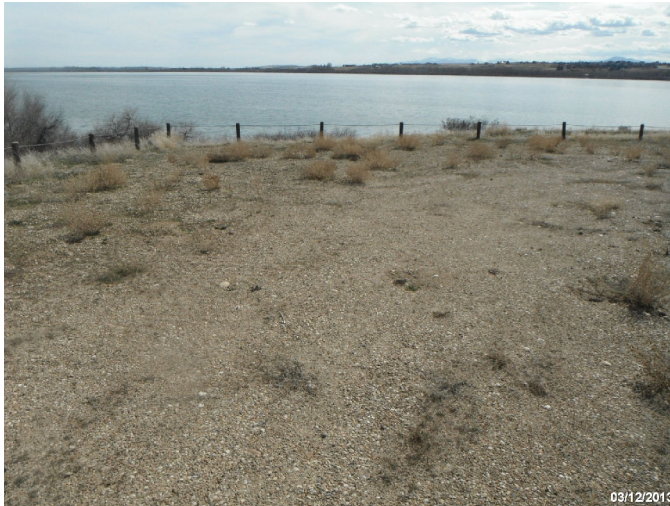
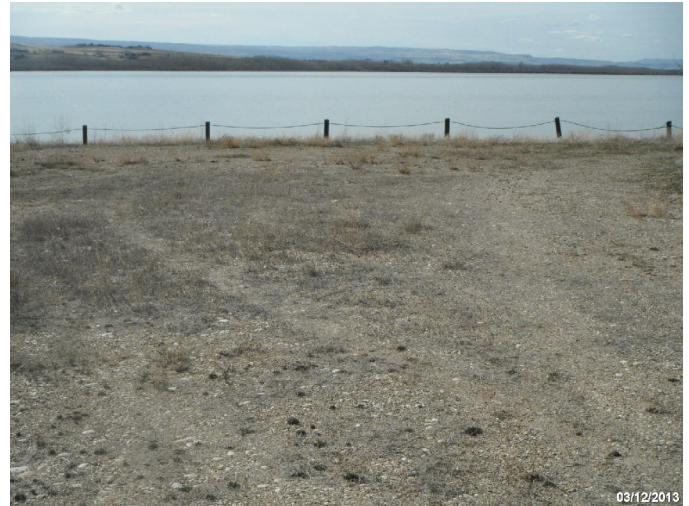
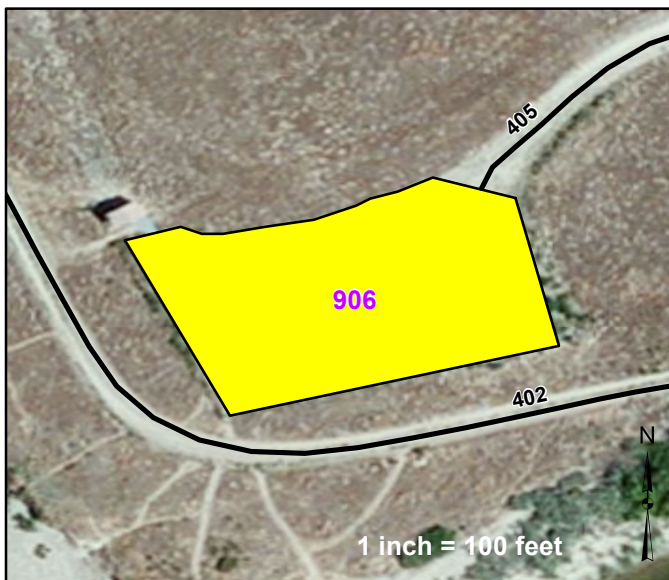
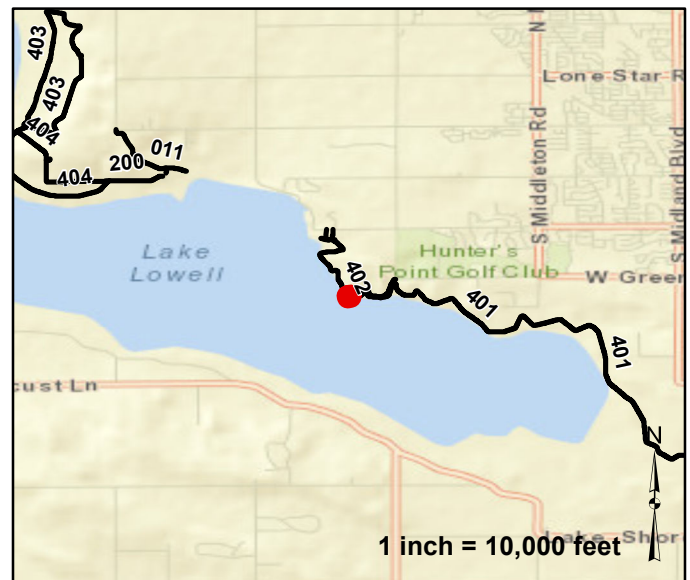
From Gott's Point Service Road (Route 405)

Asset Number	Area (Sq Ft)	Spaces	Condition	Surface Type	Cost to Improve	Inspection Date	Current Replacement Value
10042379	12857	14	Fair	Gravel	\$3,500	05-17-2004	\$64,900

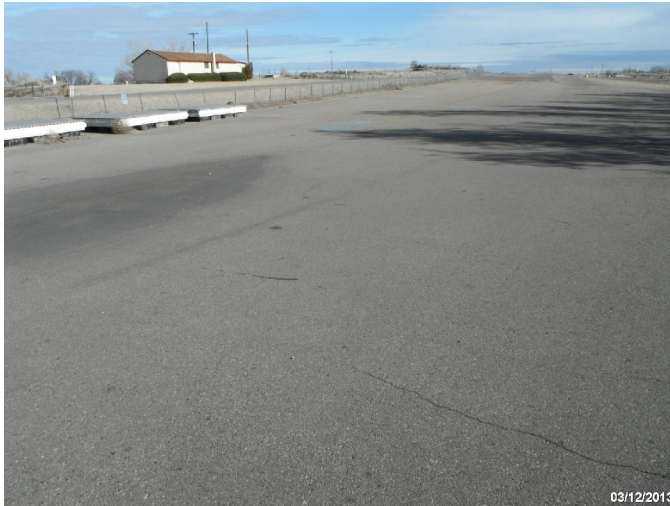
From Lower Dam Boat Ramp Access Road (Route 101)

Asset Number	Area (Sq Ft)	Spaces	Condition	Surface Type	Cost to Improve	Inspection Date	Current Replacement Value
10005337	75936	52	Fair	Asphalt	\$66,300	03-12-2013	\$702,600

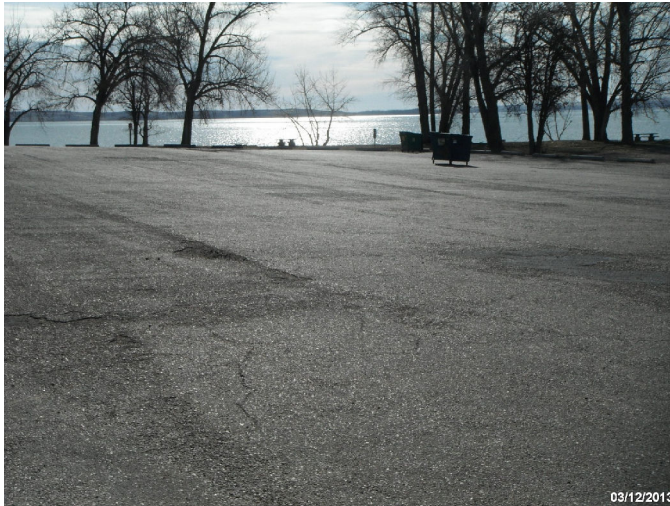
From Lower Dam Youth Camp Access Road (Route 102)

Asset Number	Area (Sq Ft)	Spaces	Condition	Surface Type	Cost to Improve	Inspection Date	Current Replacement Value
10005338	67454	134	Poor	Asphalt	\$329,600	03-12-2013	\$624,100

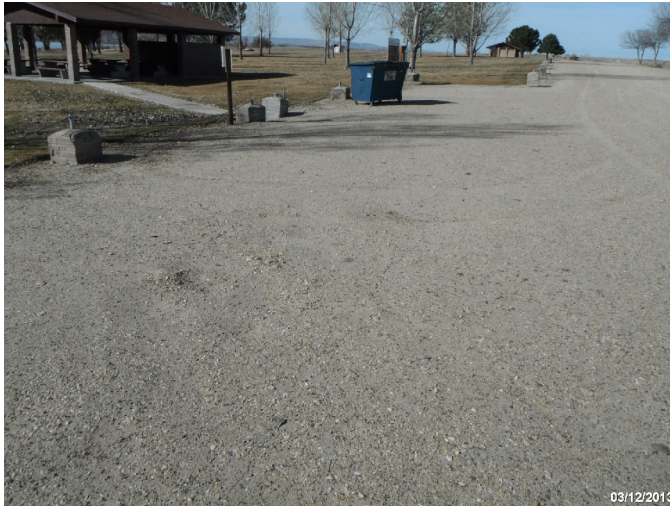
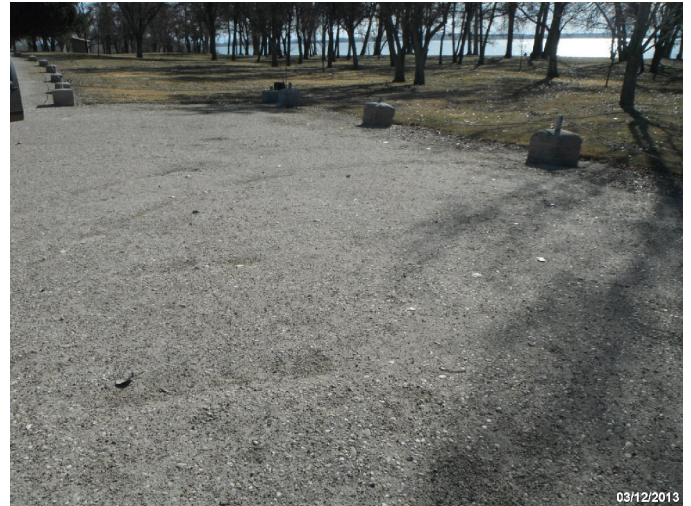
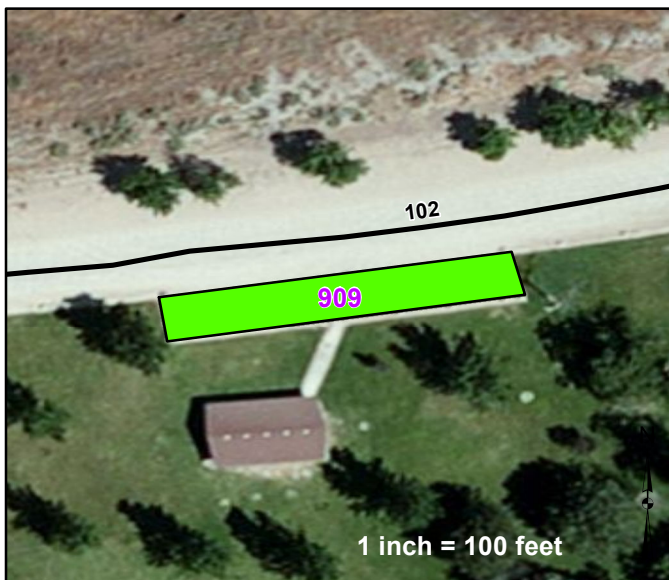
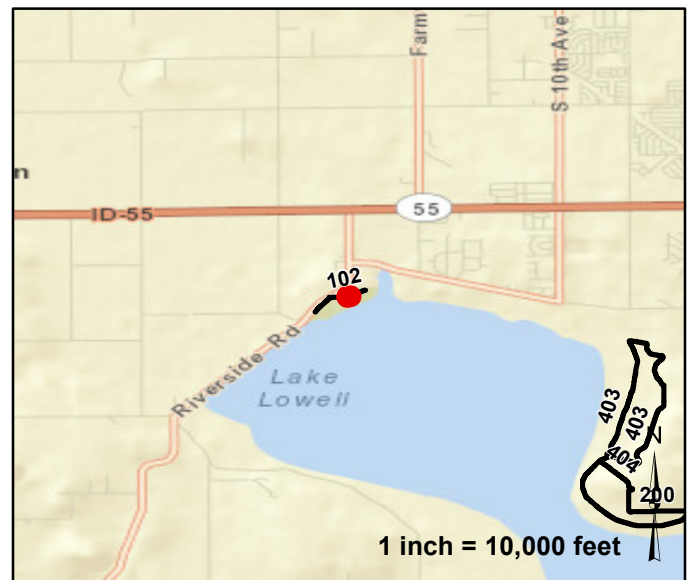
From Lower Dam Youth Camp Access Road (Route 102)

Asset Number	Area (Sq Ft)	Spaces	Condition	Surface Type	Cost to Improve	Inspection Date	Current Replacement Value
10042380	3143	15	Good	Gravel	\$500	03-12-2013	\$15,900

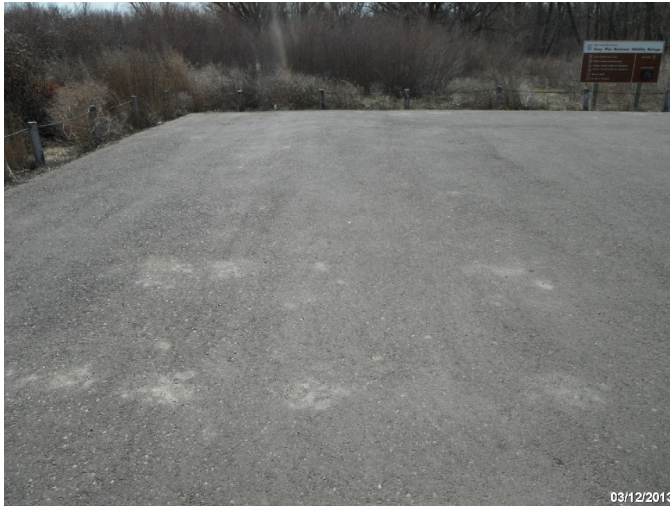
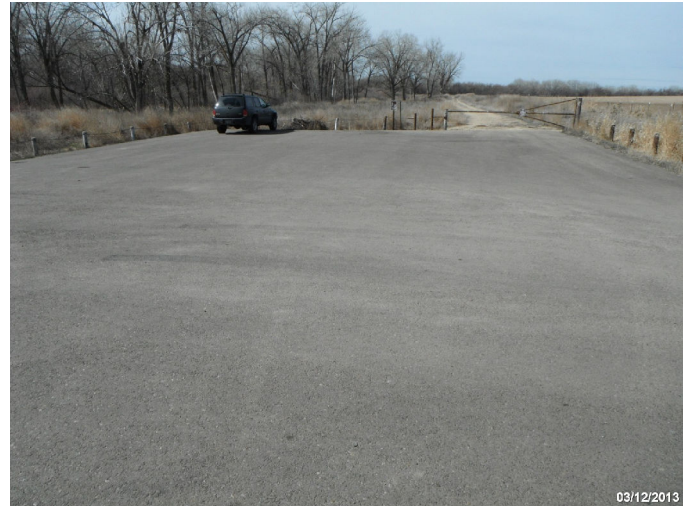
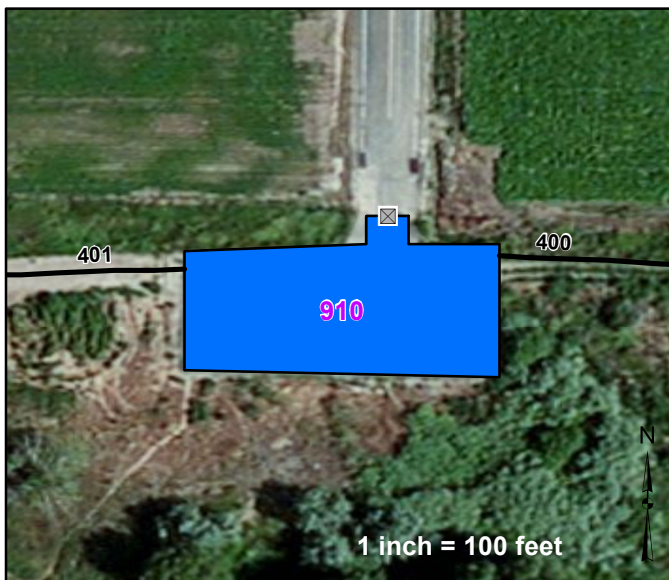
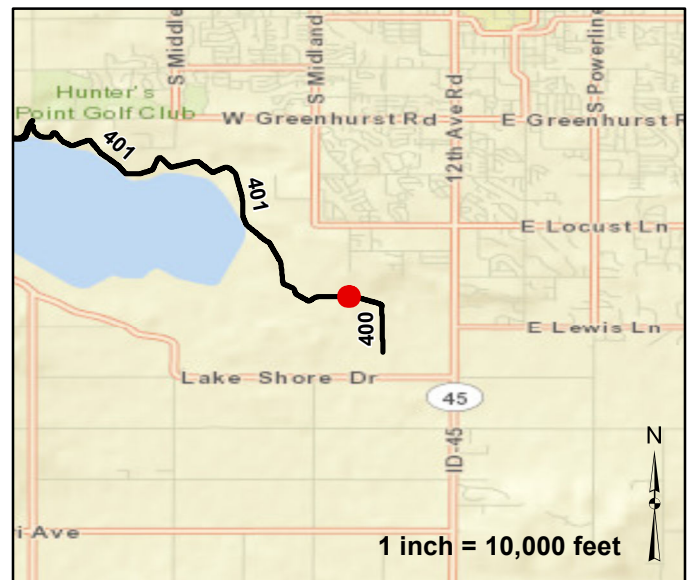
From Tio Lane

Asset Number	Area (Sq Ft)	Spaces	Condition	Surface Type	Cost to Improve	Inspection Date	Current Replacement Value
10050909	8150	15	Excellent	Asphalt	\$0	03-12-2013	\$75,400

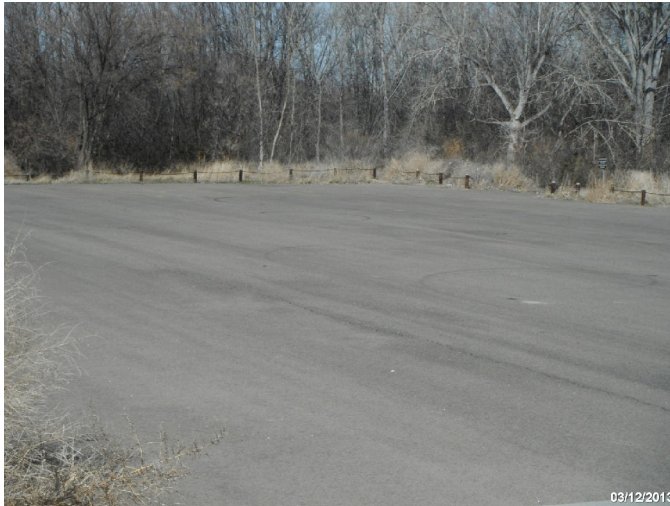
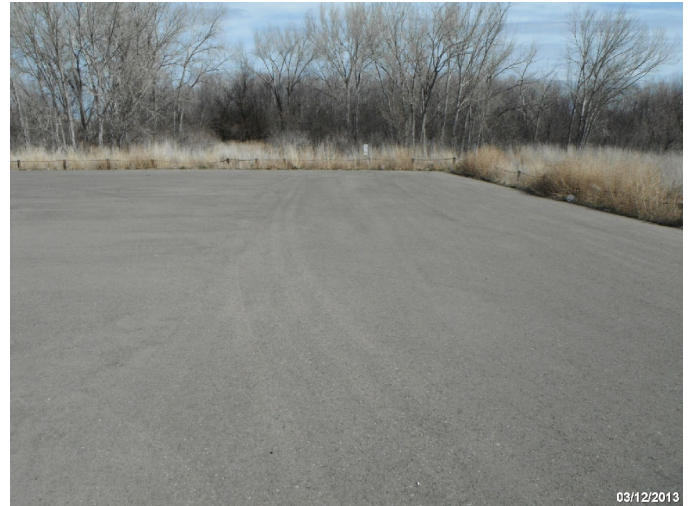
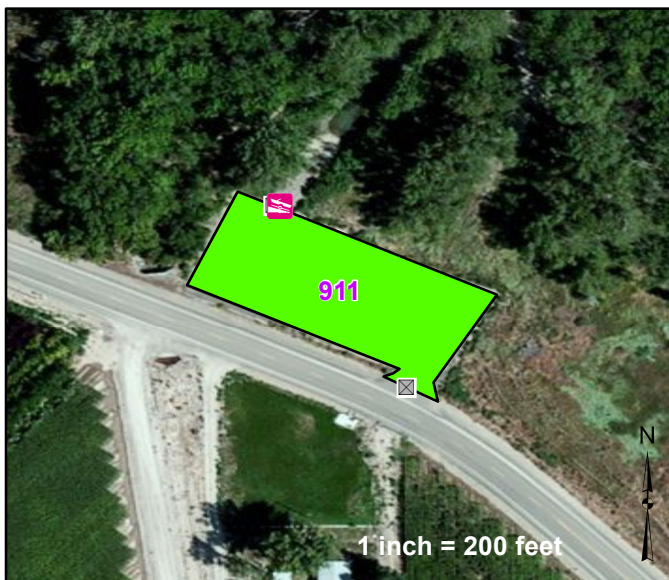
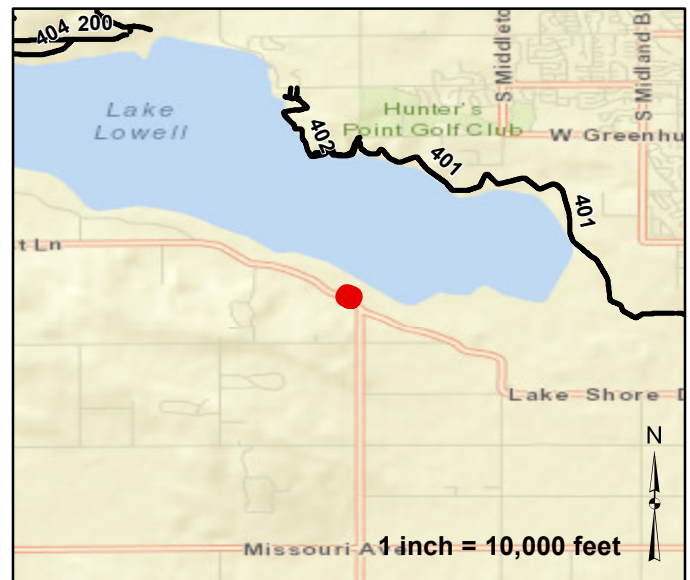
**Route Number: 911**  
**Lake Shore Drive Parking #1**  
**From Lake Shore Drive**

Asset Number	Area (Sq Ft)	Spaces	Condition	Surface Type	Cost to Improve	Inspection Date	Current Replacement Value
10005336	23071	40	Good	Asphalt	\$4,400	03-12-2013	\$213,500

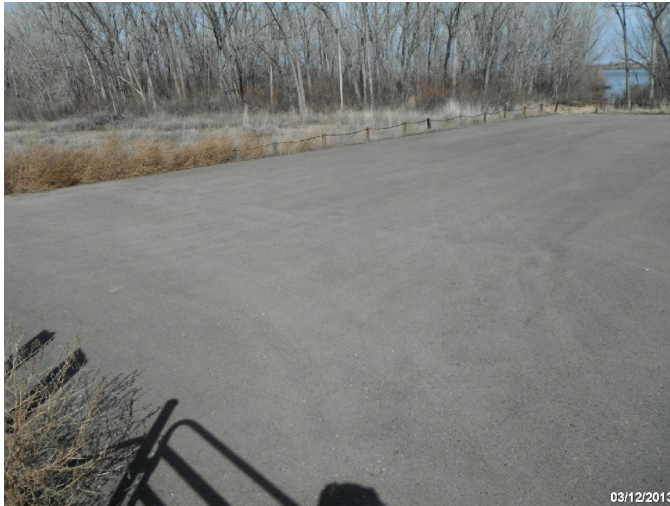
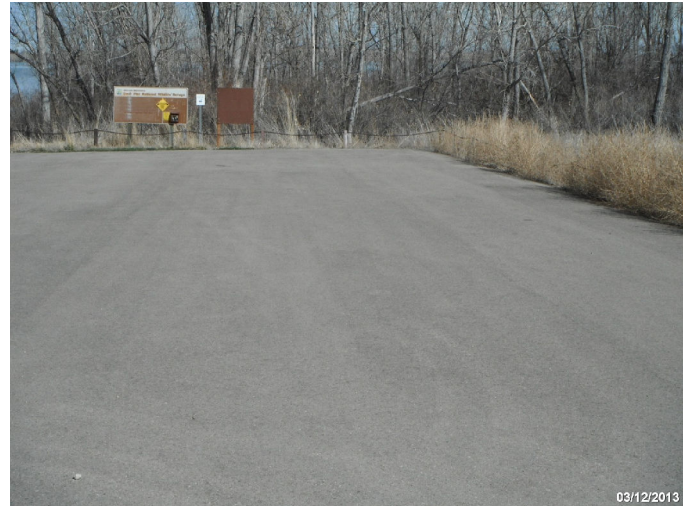
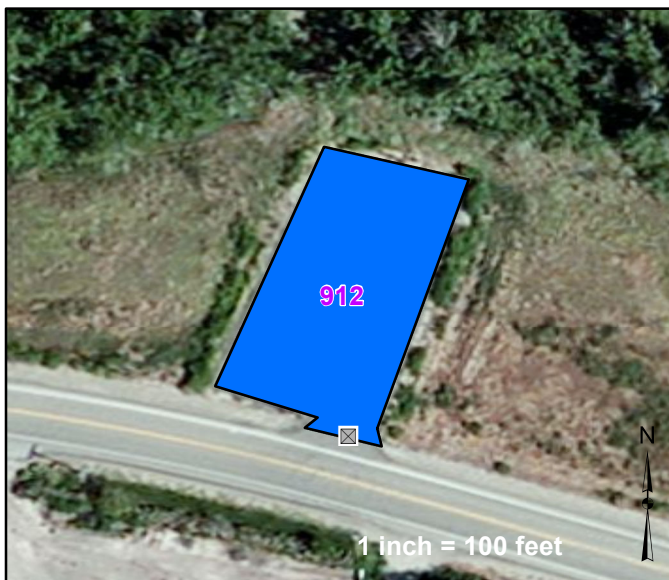
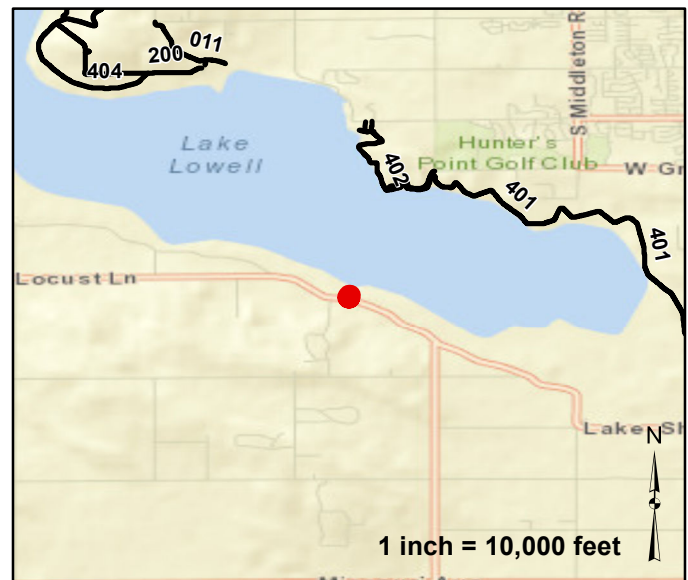
**Route Number: 912**  
**Lake Shore Drive Parking #2**  
**From Lake Shore Drive**

Asset Number	Area (Sq Ft)	Spaces	Condition	Surface Type	Cost to Improve	Inspection Date	Current Replacement Value
10005336	8383	15	Excellent	Asphalt	\$0	03-12-2013	\$77,600

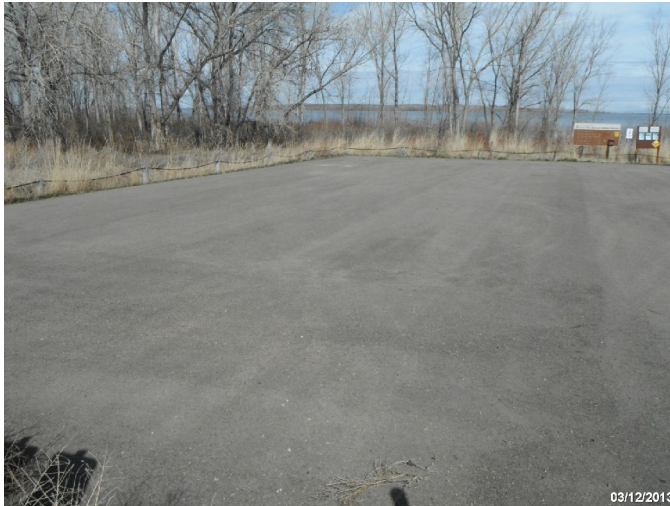
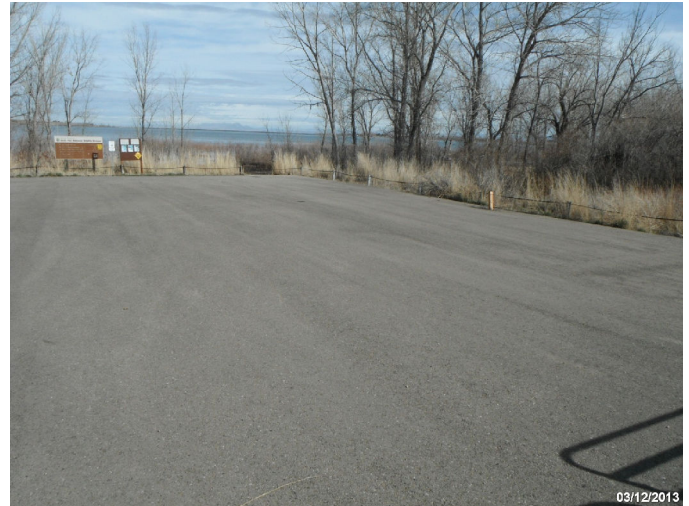
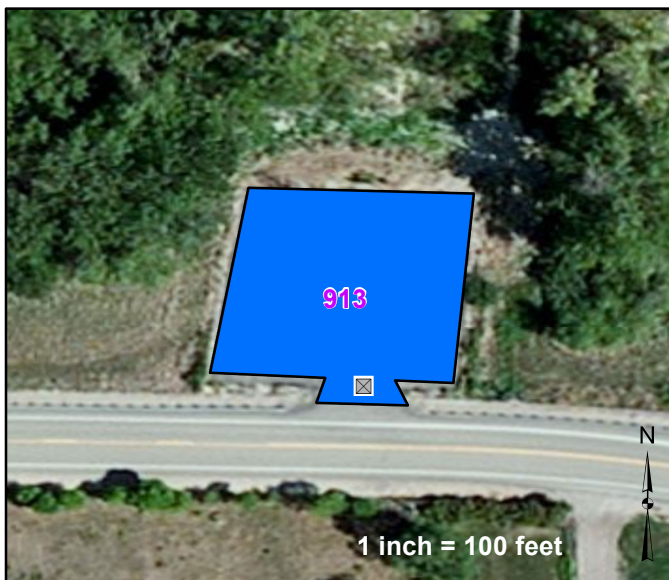
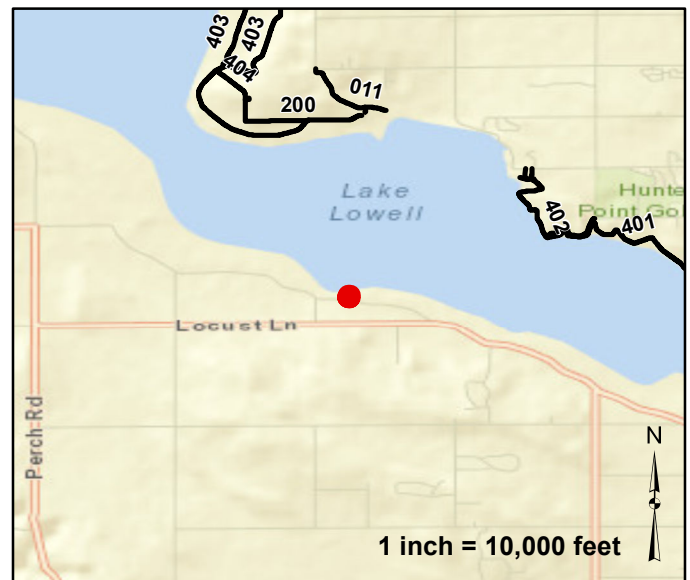
**Route Number: 913**  
**Lake Shore Drive Parking #3**  
**From Lake Shore Drive**

Asset Number	Area (Sq Ft)	Spaces	Condition	Surface Type	Cost to Improve	Inspection Date	Current Replacement Value
10005336	9069	20	Excellent	Asphalt	\$0	03-12-2013	\$83,900

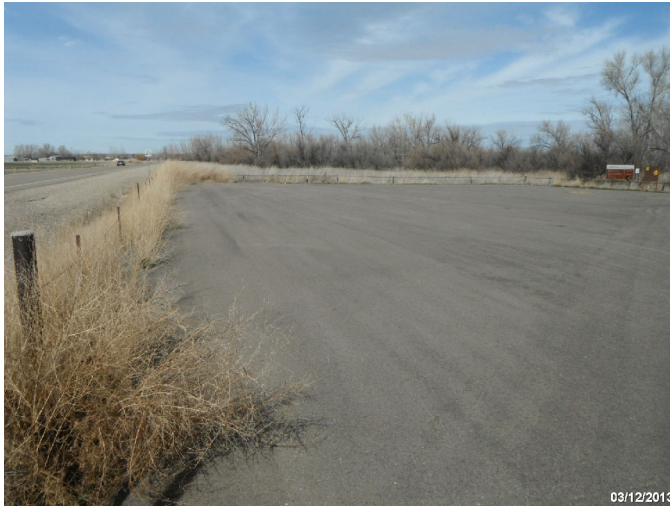
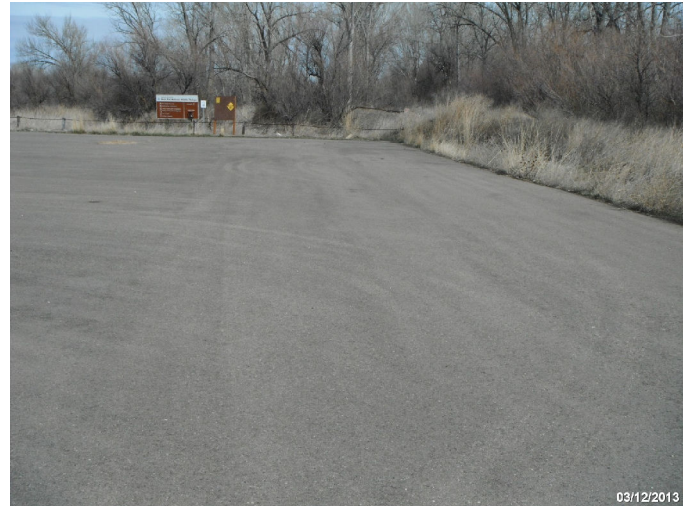
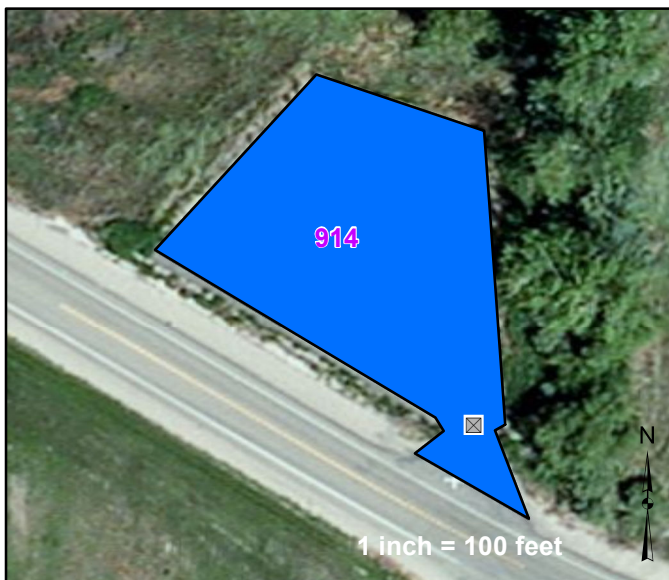
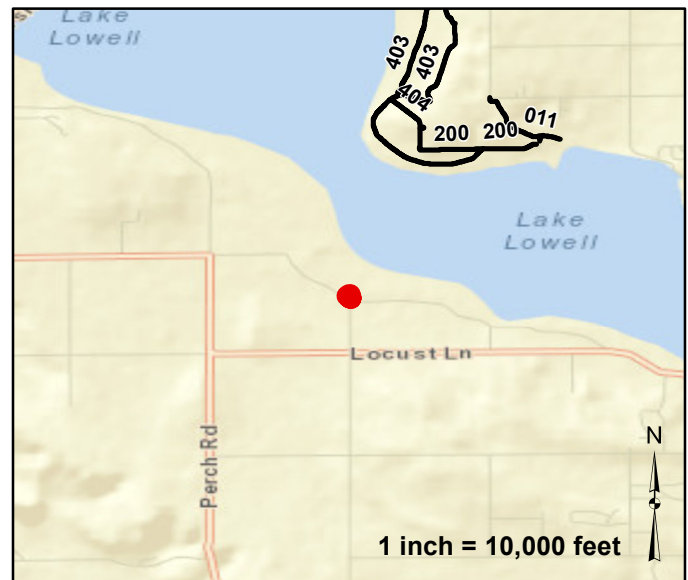
**Route Number: 914**  
**Lake Shore Drive Parking #4**  
**From Lake Shore Drive**

Asset Number	Area (Sq Ft)	Spaces	Condition	Surface Type	Cost to Improve	Inspection Date	Current Replacement Value
10005336	15523	15	Excellent	Asphalt	\$0	03-12-2013	\$143,600

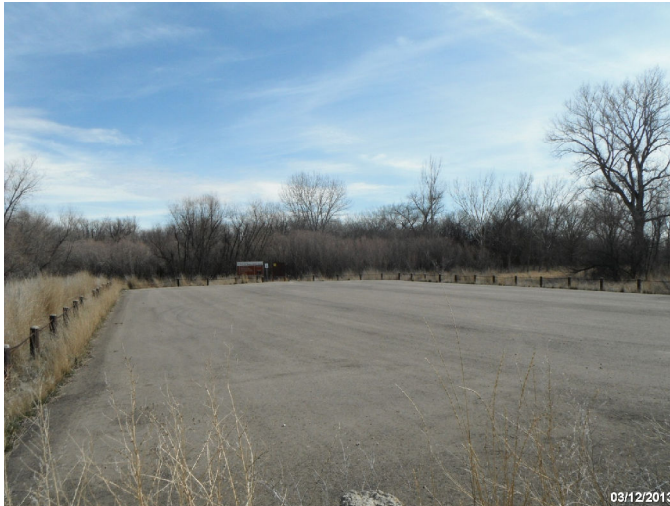
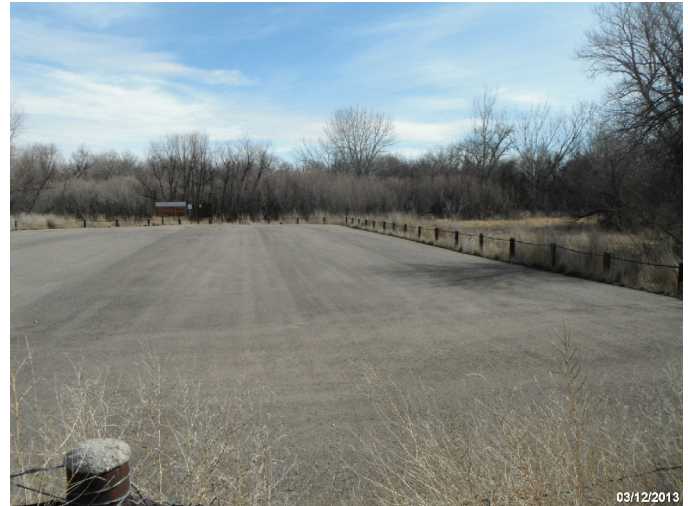
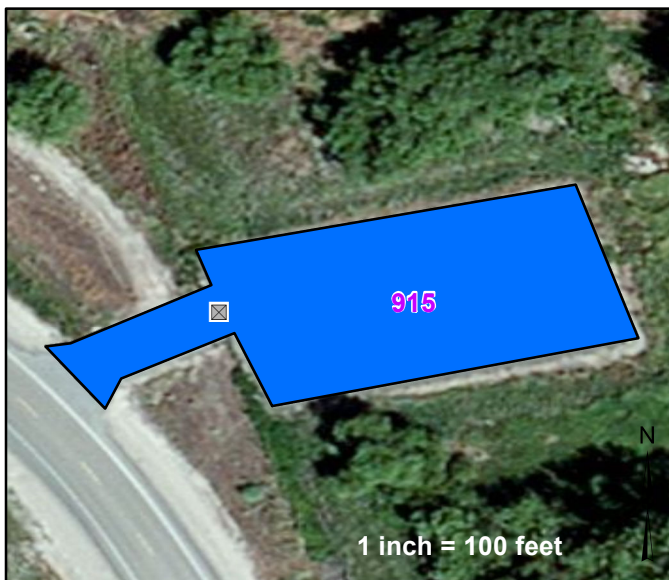
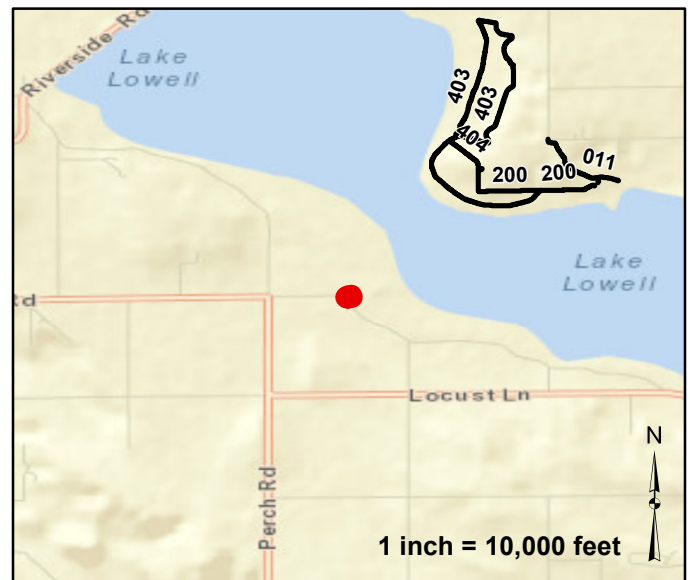
**Route Number: 915**  
**Lake Shore Drive Parking #5**  
**From Lake Shore Drive**

Asset Number	Area (Sq Ft)	Spaces	Condition	Surface Type	Cost to Improve	Inspection Date	Current Replacement Value
10005336	14130	25	Excellent	Asphalt	\$0	03-12-2013	\$130,700

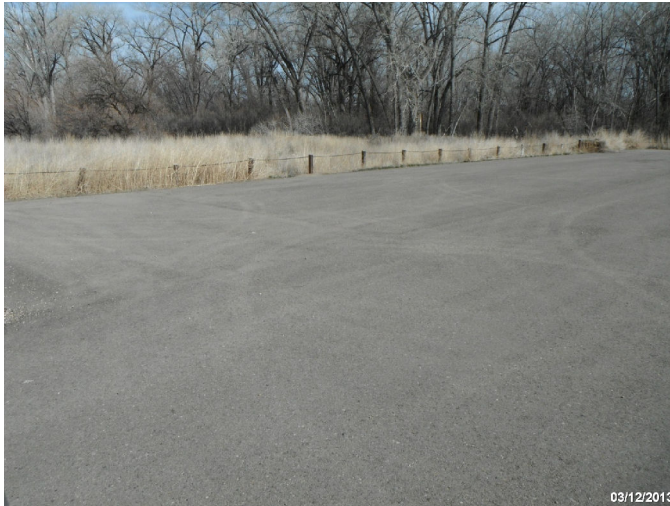
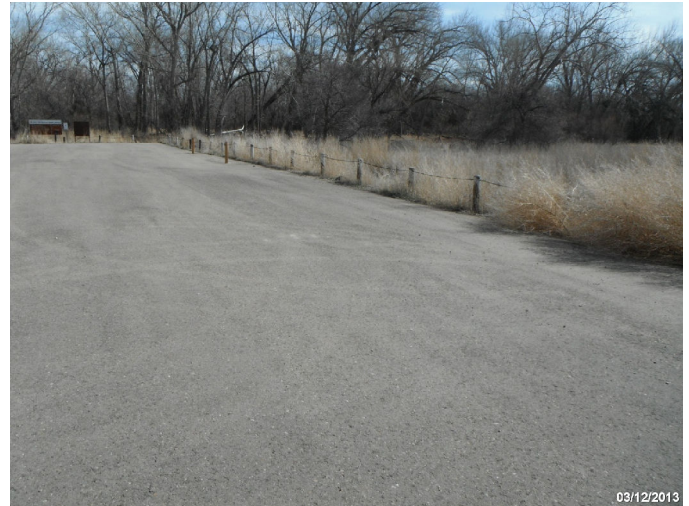
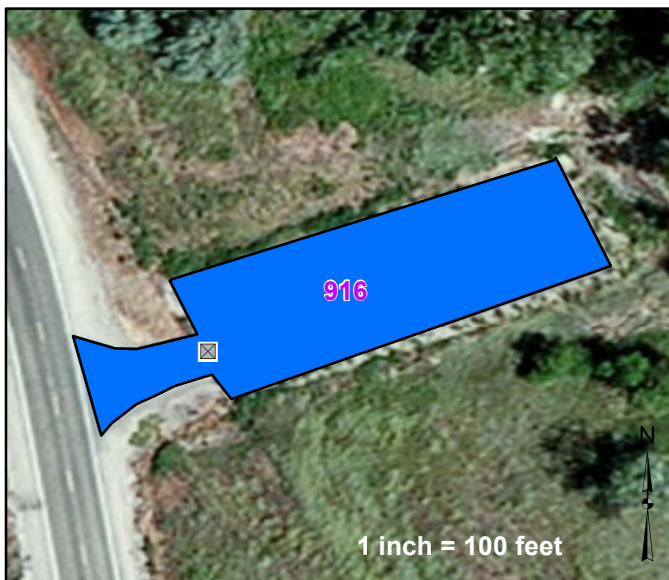
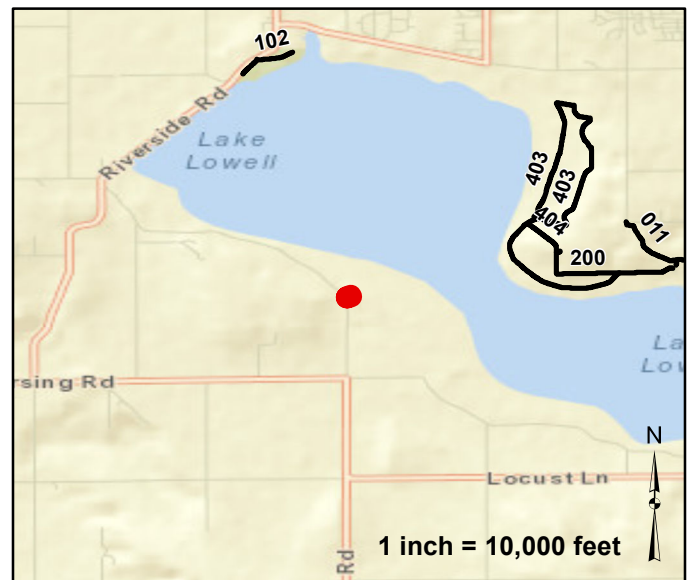
**Route Number: 916**  
**Lake Shore Drive Parking #6**  
**From Lake Shore Drive**

Asset Number	Area (Sq Ft)	Spaces	Condition	Surface Type	Cost to Improve	Inspection Date	Current Replacement Value
10005336	11384	30	Excellent	Asphalt	\$0	05-17-2004	\$105,300

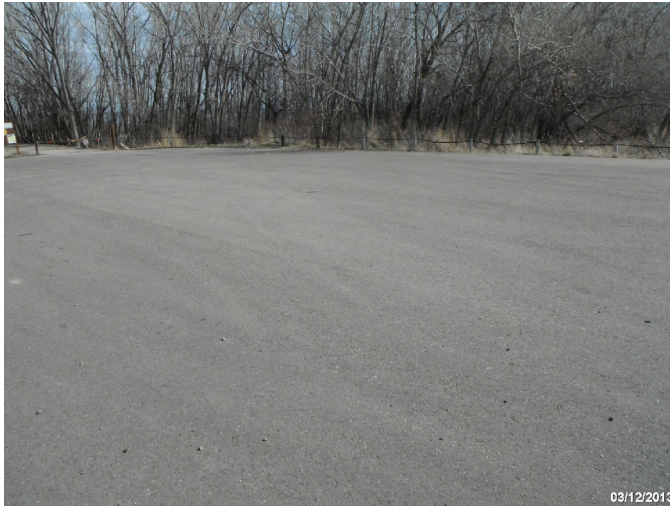
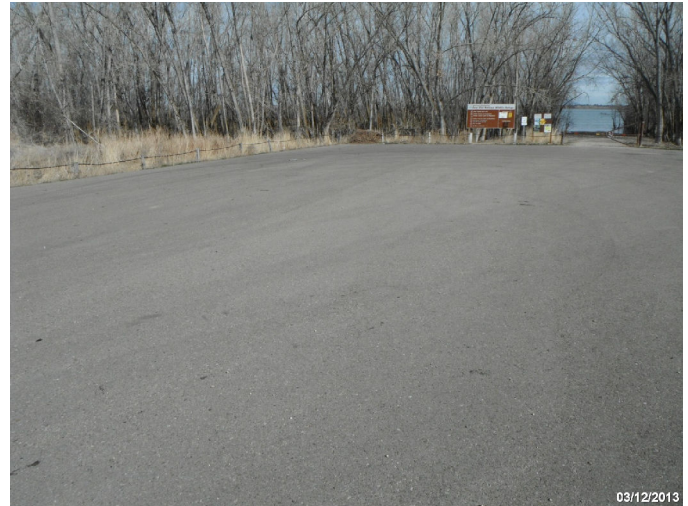
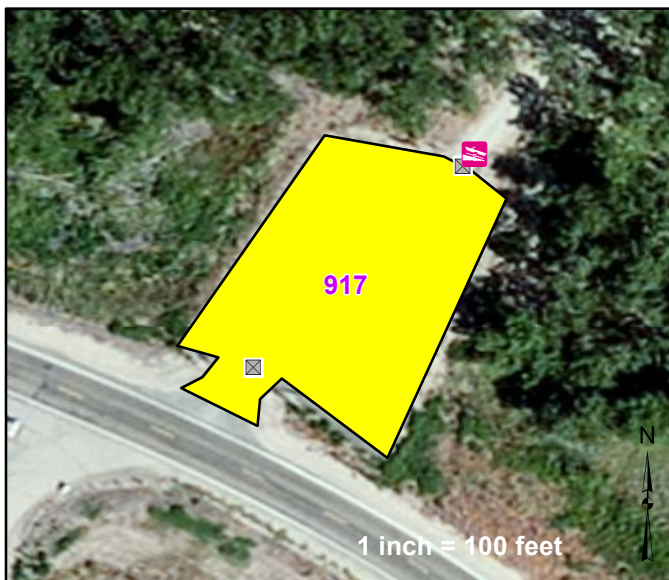
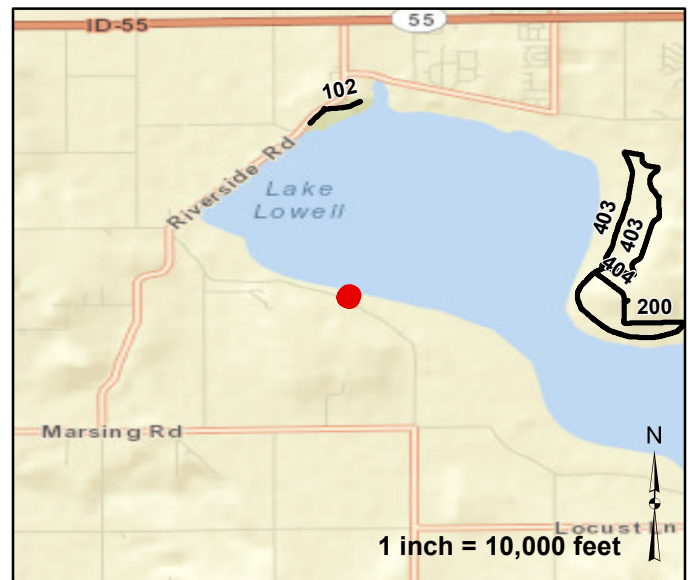
**Route Number: 917**  
**Lake Shore Drive Parking #7**  
**From Lake Shore Drive**

Asset Number	Area (Sq Ft)	Spaces	Condition	Surface Type	Cost to Improve	Inspection Date	Current Replacement Value
10005336	11898	25	Fair	Asphalt	\$10,400	03-12-2013	\$110,100

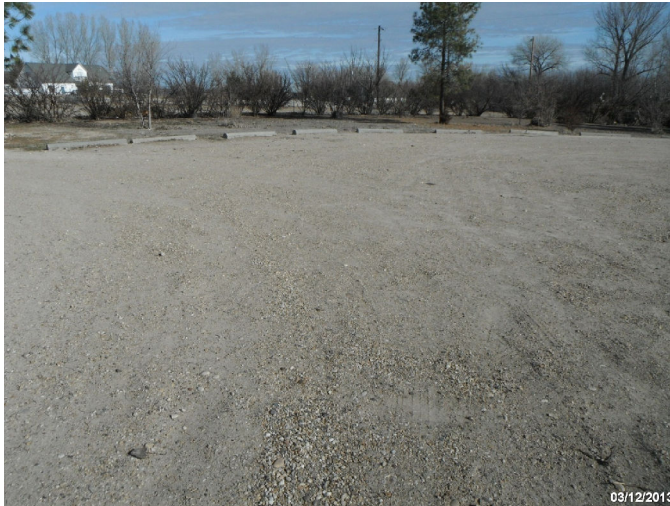
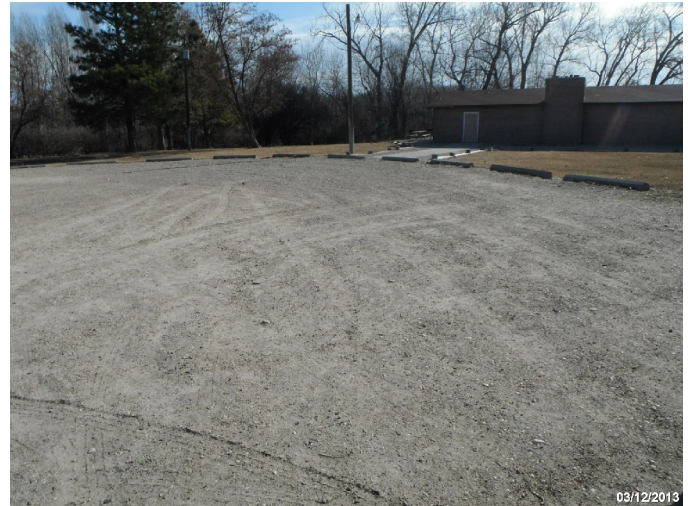
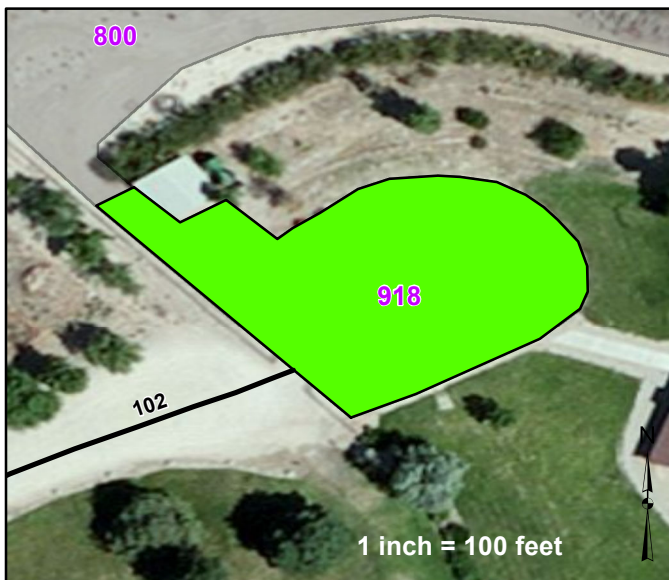
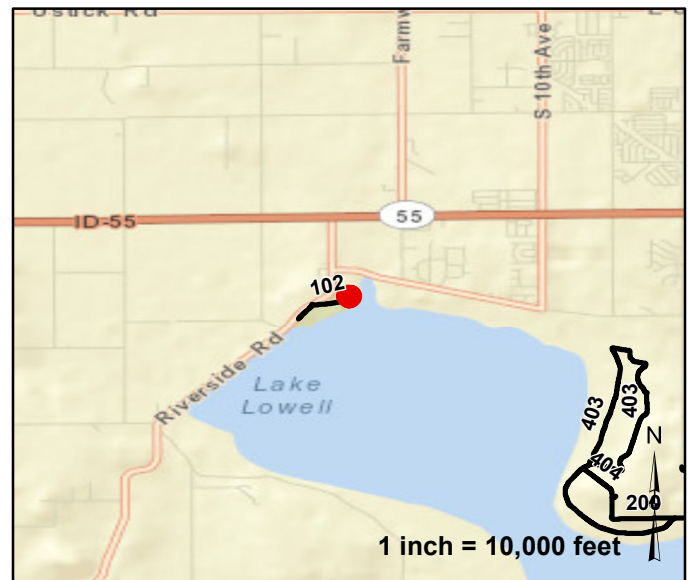
# Route Number: 918

Asset Number	Area (Sq Ft)	Spaces	Condition	Surface Type	Cost to Improve	Inspection Date	Current Replacement Value
-	13235	24	Good	Gravel	\$2,000	03-12-2013	\$66,800

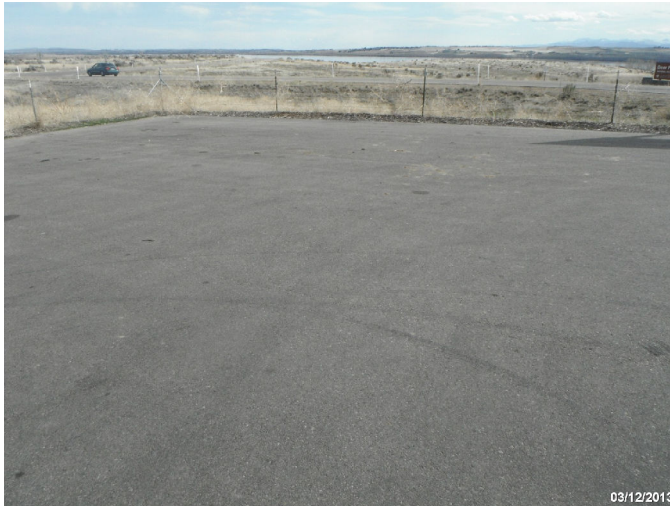
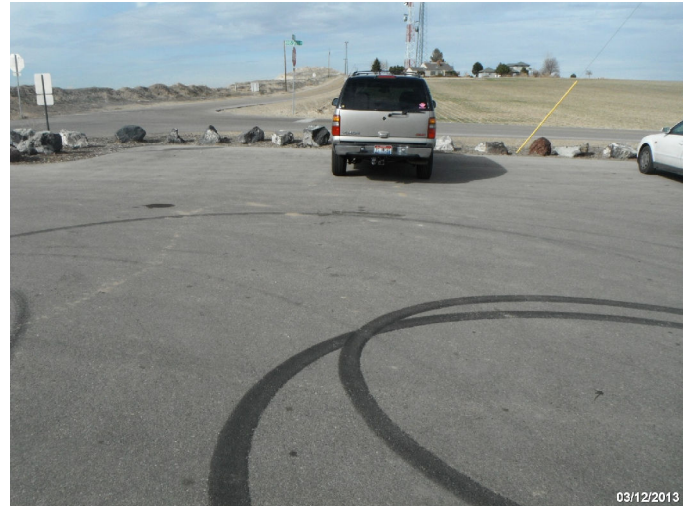
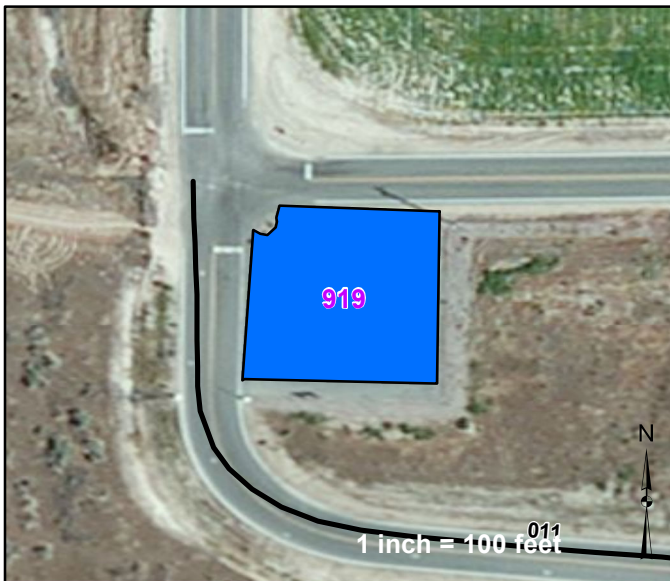
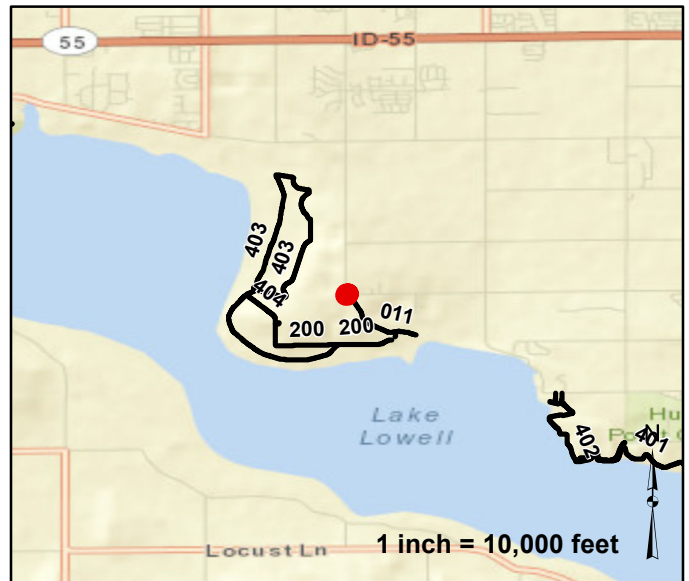
**Route Number: 919**  
**Upper Entrance Parking**  
**From Upper Embankment Road (Route 011)**

Asset Number	Area (Sq Ft)	Spaces	Condition	Surface Type	Cost to Improve	Inspection Date	Current Replacement Value
-	6348	20	Excellent	Asphalt	\$0	03-12-2013	\$58,700

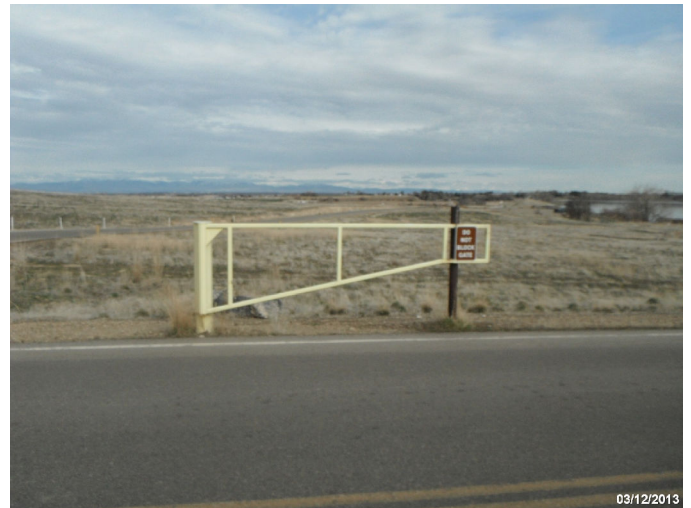
Photo: DEFL\_C4\_0131 Route: 010-001-0.0  
Metal Open Rail Gate

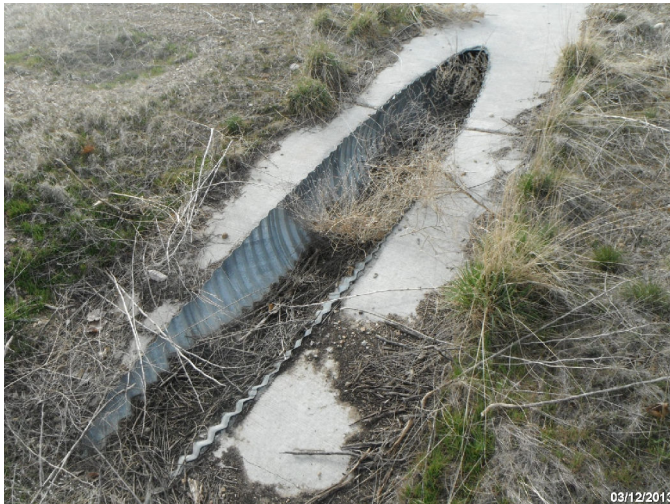
Photo: DEFL\_C4\_0132 Route: 010-001-0.03  
Metal Culvert 55ft long 24in dia. 2ft deep

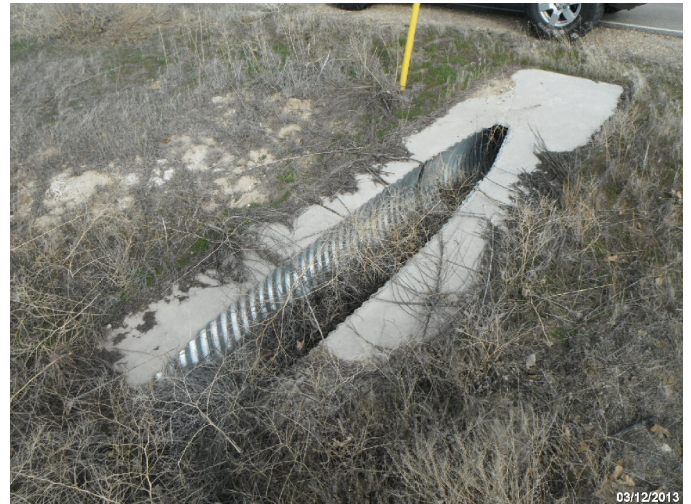
Photo: DEFL\_C4\_0133 Route: 010-001-0.03  
Metal Culvert 55ft long 24in dia. 2ft deep

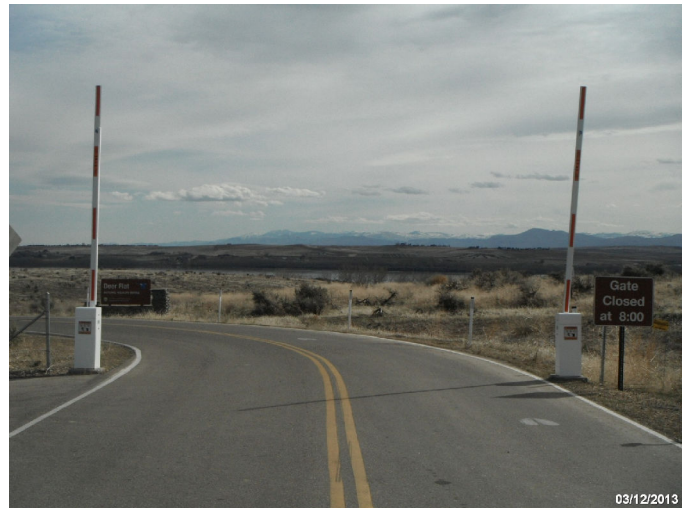
Photo: DEFL\_C4\_0113 Route: 011-001-0.01  
PVC Open Rail Gate electric

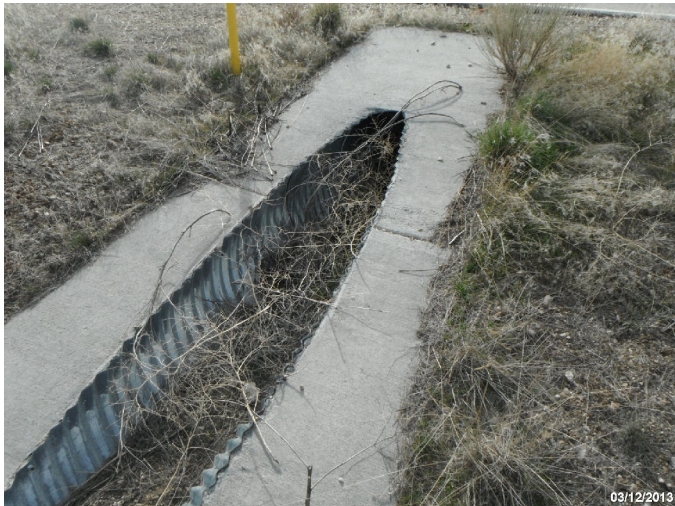
Photo: DEFL\_C4\_0114 Route: 011-001-0.23  
Metal Culvert 60ft long 18in dia. 2ft deep

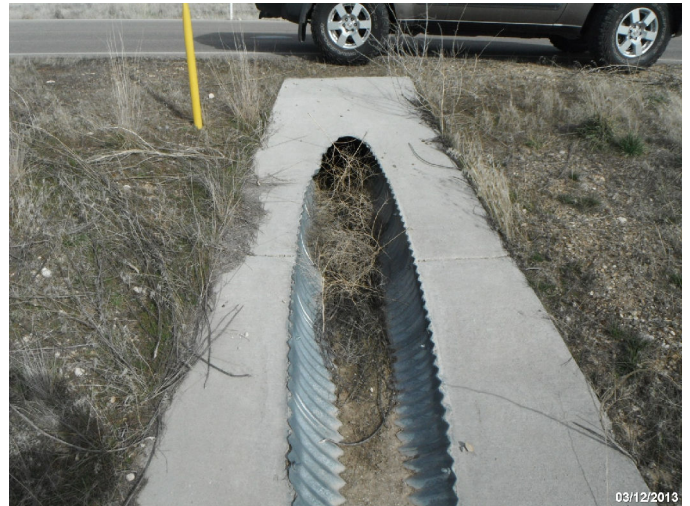
Photo: DEFL\_C4\_0115 Route: 011-001-0.23  
Metal Culvert 60ft long 18in dia. 2ft deep
